Answers To Some Mysterious Complaints On Chrysler Manual Transmissions

By Mike Weinberg
Contributing Editor

This bulletin involves installing a stronger spring for the reverse detent.

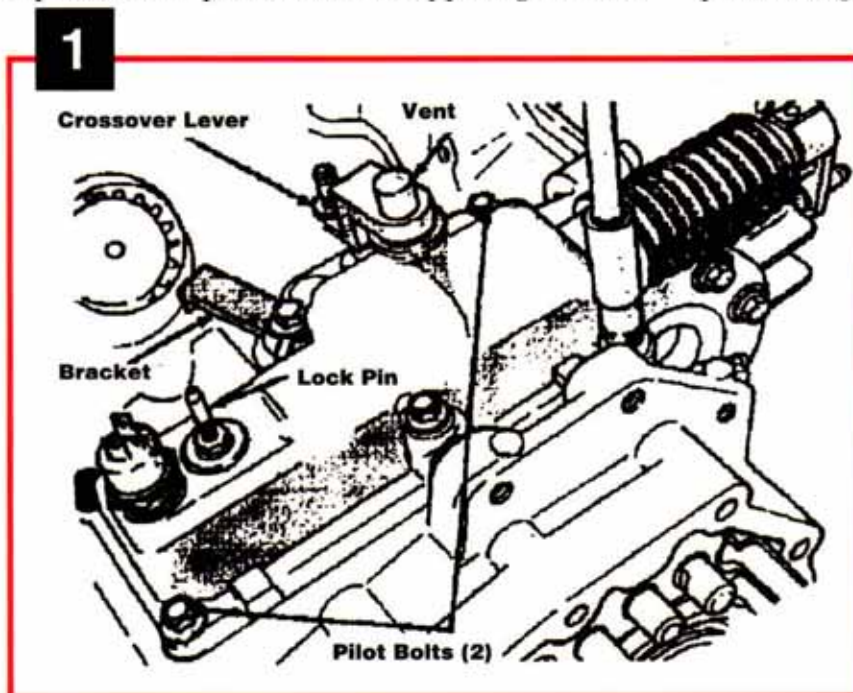
1. With the shifter in neutral, remove the lock pin on the gearshift housing and reinstall with the long end down (Refer to Figure 1). If the transaxle is not equipped with a lock pin, skip to step 2.

ing. Apply Mopar Gasket Maker, P/N 4318083, and install the gearshift housing using new bolts. Note the position of the shouldered pilot-bolt locations (Refer to Figure 1). Torque the six bolts to 28 N-m (21 ft/lbs.).

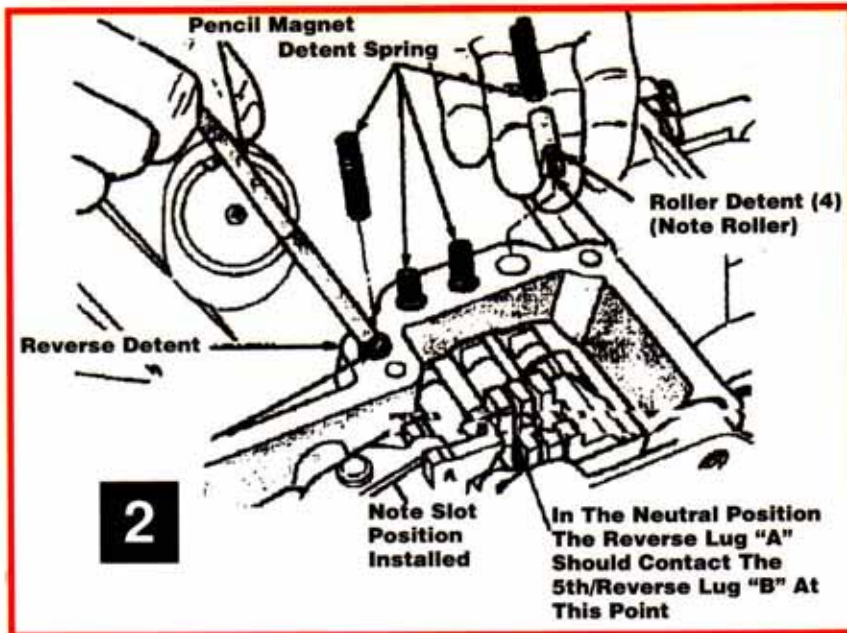
4. Ensure the reverse lug is in the neutral position. The reverse lug should be shifted fully toward the engine and contact the 5th reverse lug (Refer to Figure 2).

5. Replace the original reverse detent spring with revised spring P/N 4798366 (Refer to Figure 2).

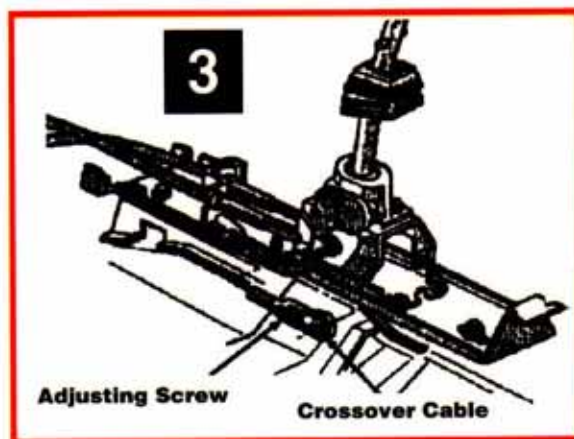
B. Loosen the screw to allow the crossover-cable adjustment fitting to slide freely (Refer to Figure 3).
